Assessment and Rehabilitation of Concrete Buildings

IV. CASE STUDY

- Address : Omdurman Almohandsein

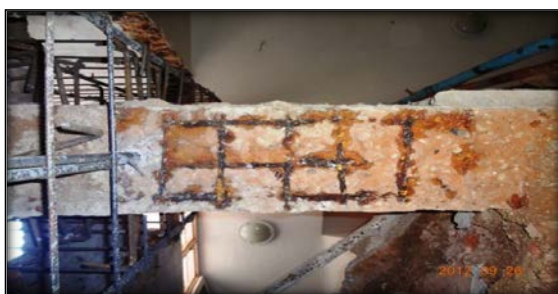
This resulting some cracks at the soffit of grade beams which is led concrete cover to fall as well as minimization the nominal diameter of main bars and shear stirrups as shown in Fig. 2.

Fig. 2: Severe corrosion on grade beam reinforcement.

Steel jacketing consists from steel angles and strips 2 inches to tie the old beam in order to strengthen its sectors in accordance to comments of supervisor engineer and graphics, inserting steel jacketing for new columns then made a concrete cover of thickness 10 cm around perimeter of the old beam.

At the end, underground grade beam have been painted by bituminous coating to protect it from corrosion in future.

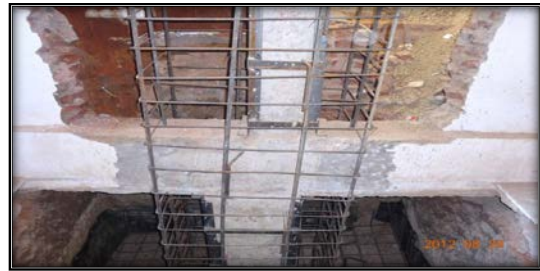
Which resulting in some cracks that led discontinuity of column reinforcement into foundation as shown in Fig. 3.

Fig. 3: Severe corrosion on steel bars of eccentrically loaded columns.

All columns were constructed by using reinforced concrete according to supervisor engineer comments who is required C7 center column to be increased from old section (250×450 mm) to new section (650×900 mm) with an increasing percentage of 160%. Also columns (C21) corner column and (C10) edge column were constructed from old section (250×250) mm to new section (650×900) mm with an enlargement percentage of 416%.

The new column is inserted on the second floor and reinforced by eight (8) bars 16 mm with shear stirrups 8mm at every 20 cm in accordance to comments of supervisor engineer and graphics.

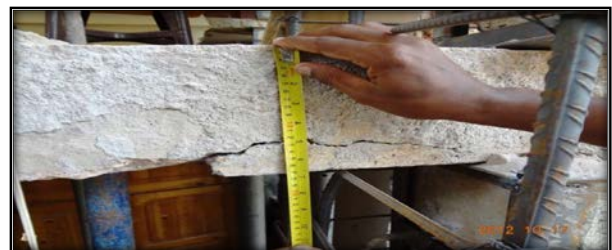
All slabs on all floors are established as flat slab with depth ranges between 17 cm to 20 cm as shown in Fig. 4.

Fig. 4: Measuring depth of flat slab.

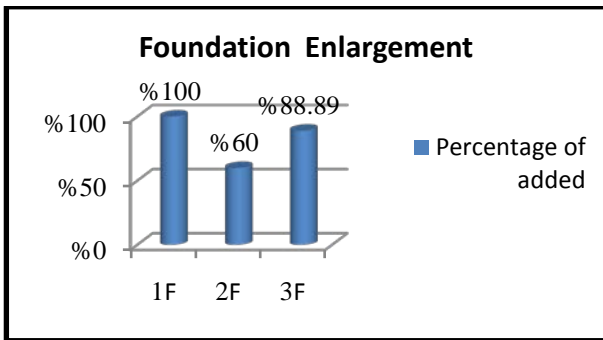
From above tables, we evaluate that the enlargement percentage for (F1) is 100% from old section, also the enlargement percentages for (F3) and (F2) are 88.89% and 60%, respectively from old sections.

Fig. 5: Enlargement Percentage of Foundation.

foundations are constructed upper the existing ones by using a reinforced concrete according to supervisor engineer comments that require F1 from (1.2×1.2) m to (2.4×2.4) m with depth 50cm and with increasing percentage of 100%, F2 constructed from (1.5×1.5) m to (2.4×2.4) m with depth 50cm and with enlargement percentage of 60%, and F3 increased from (1.8×1.8) m to (3.4×3.4) m with depth 55cm and with enlargement percentage of 88.89%.

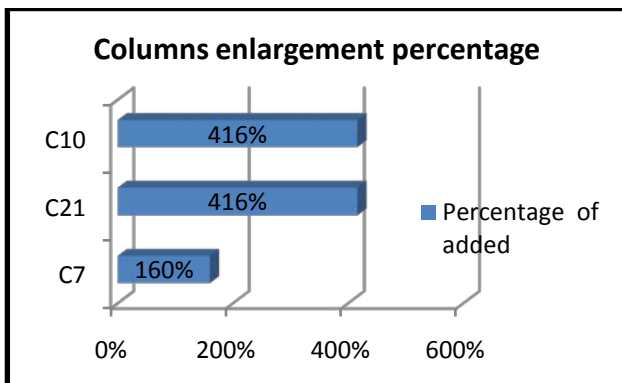
From TABLE 6, we evaluate that the enlargement percentage for center columns (C7) is 160% from old section, Moreover the enlargement percentage for the corner column (C21) and the edge (C10) is 416% and 416%, respectively from old section.

Fig. 8: Columns enlargement percentage.
